MAINTENANCE INFORMATION FOR MERCEDES-BENZ ACCESSORY UNIT DRIVES WITH TENSIONING ARM 55123

TECHNICAL INFO No. 1081

Mercedes-Benz	C class: C200, C220, C270
	E class: E200, E220, E270, E280, E320
	M class: ML270
	G class: G270

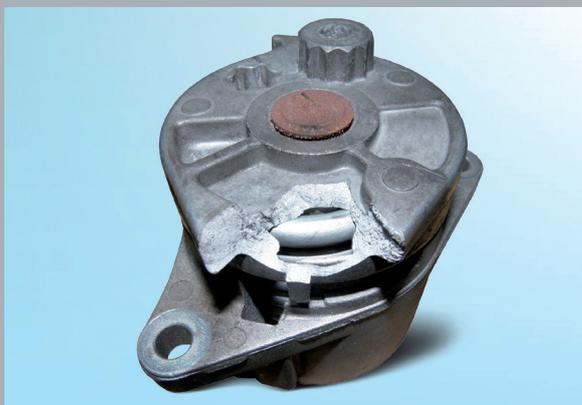
In the vehicles listed above, strong dynamic movements in the accessory unit drive may cause tensioning arm 55123 (image 3) to break. This may be caused by a worn or defective over-running alternator pulley. As a result of this, the entire accessory unit drive will fail, causing the vehicle to break down. To prevent damage, RUVILLE therefore recommends that the over-running alternator pulley (image 4) be checked and replaced if necessary.

Image 3: Example of a broken 55123 tensioning arm

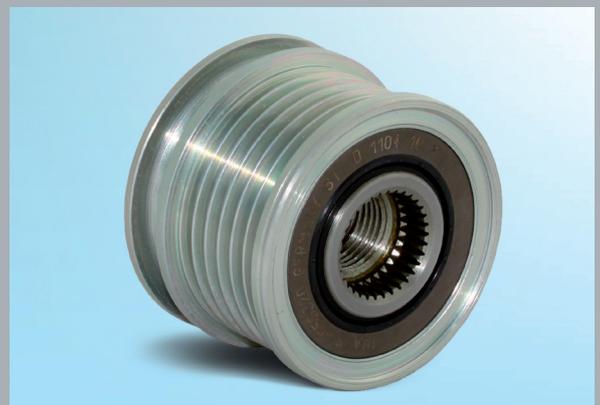
Image 4: Over-running alternator pulley
